# **Basement Construction in Ho Chi Minh Pitfalls and Collected Stories**

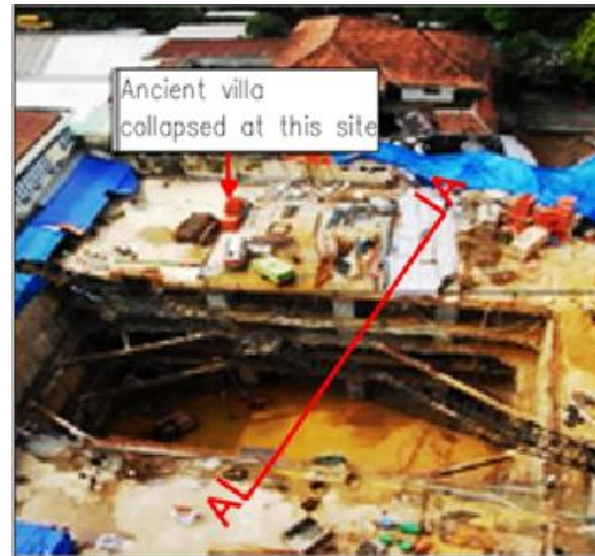
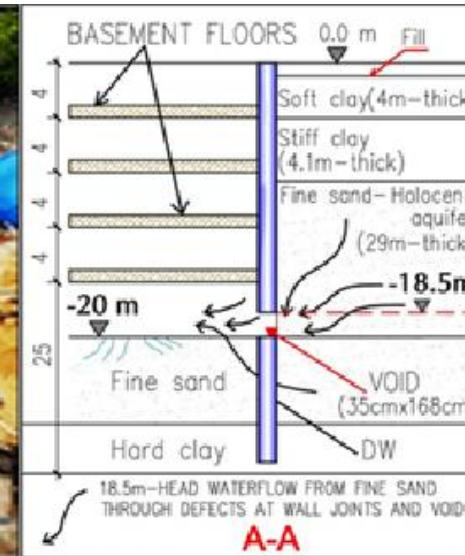
# Case 1: City Centre - May 2007

- 5-level basement; 21 storey building
- 20m deep excavation
- 1m thick, 45m deep D-wall
- Large void in D-wall: 350mm x 1700mm at -21m
- Severe water ingress could not be controlled (water head 18.5m)
- Within 30min (!), excessive subsidence occurred, severe damage to 2 storey building
- Remedial measure – jet-grouted piles

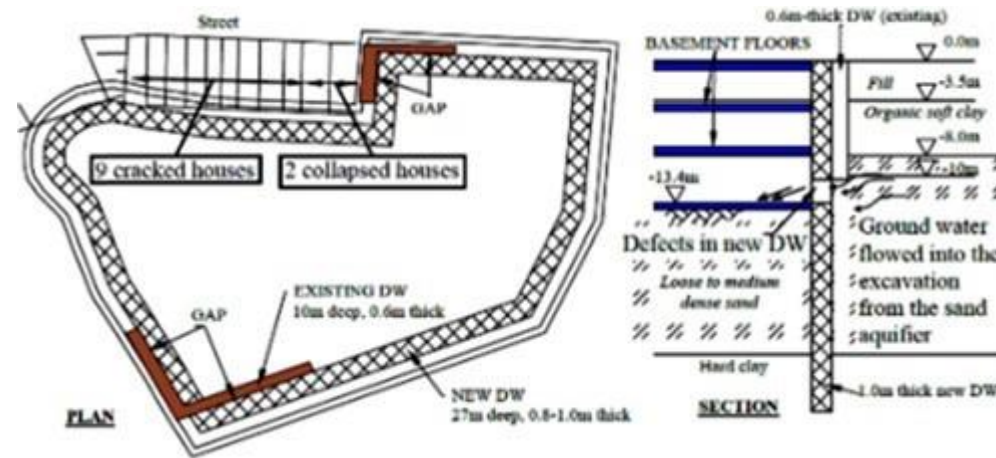
## Case 2: City Centre – January 2011

- 5-level basement; 40-storey building
- 19.8m deep excavation
- 0.8-1.0m thick, 27m deep D-wall
- Existing 600mm, 10m deep d-wall in two corners
- Existing d-wall integrated into new d-wall
- During excavation at -11m, structural failure at interface of new/old d-wall
- Severe water ingress
- 2 adjacent 2-storey buildings collapsed; 9 townhouses severely damaged.
- Remedial measures – jet-grouted piles

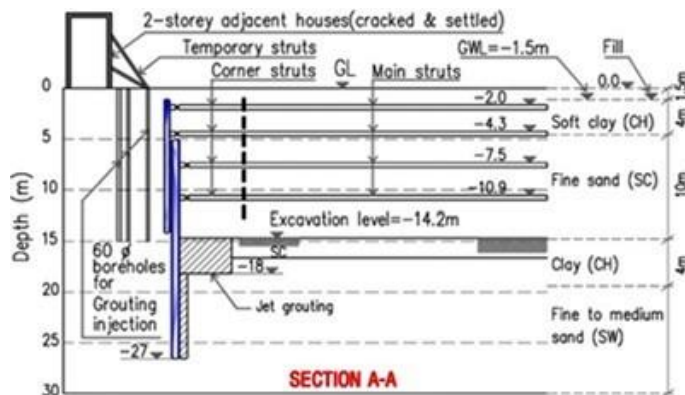
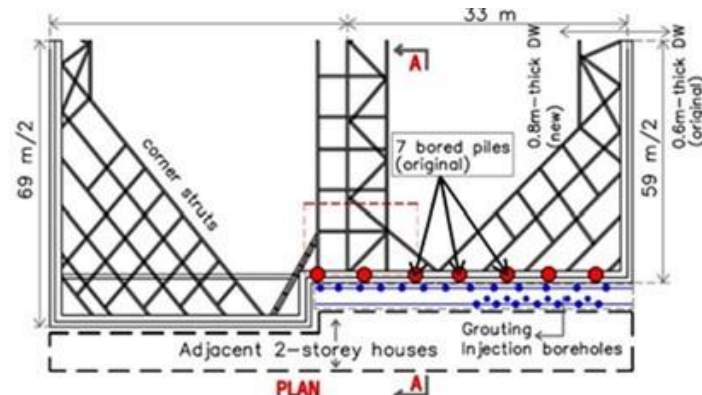
## Case 3: City Centre – April 2009

- 3-level basement; 37-storey building
- 14.0m deep excavation; 0.8m thick, 35m deep D-wall
- Existing 600mm, 12m deep d-wall in two completed (for earlier 1-level basement)
- During excavation of 3<sup>rd</sup> basement at -11m, structural failure of d-wall at interface of new/old d-wall
- Poor interface between new and original D-wall panels – large ingress of groundwater and sandy soil
- Subsidence caused damage to adjacent building.
- After almost 1 year delay, jet grouting, and needle grouting sealed the leaks

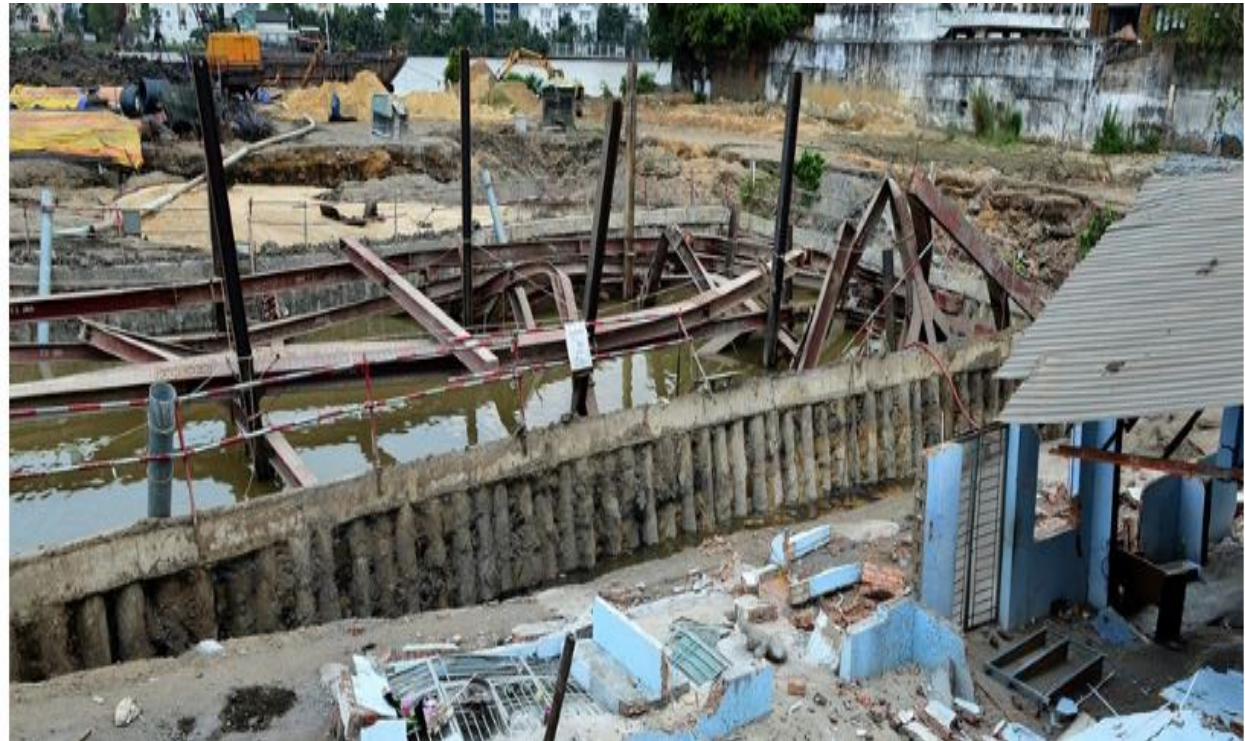
## Case 4: District 7

- 2 basement levels with - 9m-11.5m deep excavation
- Contiguous pile wall has been installed with the lateral support from temporary steel strutting
- Bottom-up construction
- Failure of the steel strutting system
- Collapse of the contig wall and damage to adjacent buildings

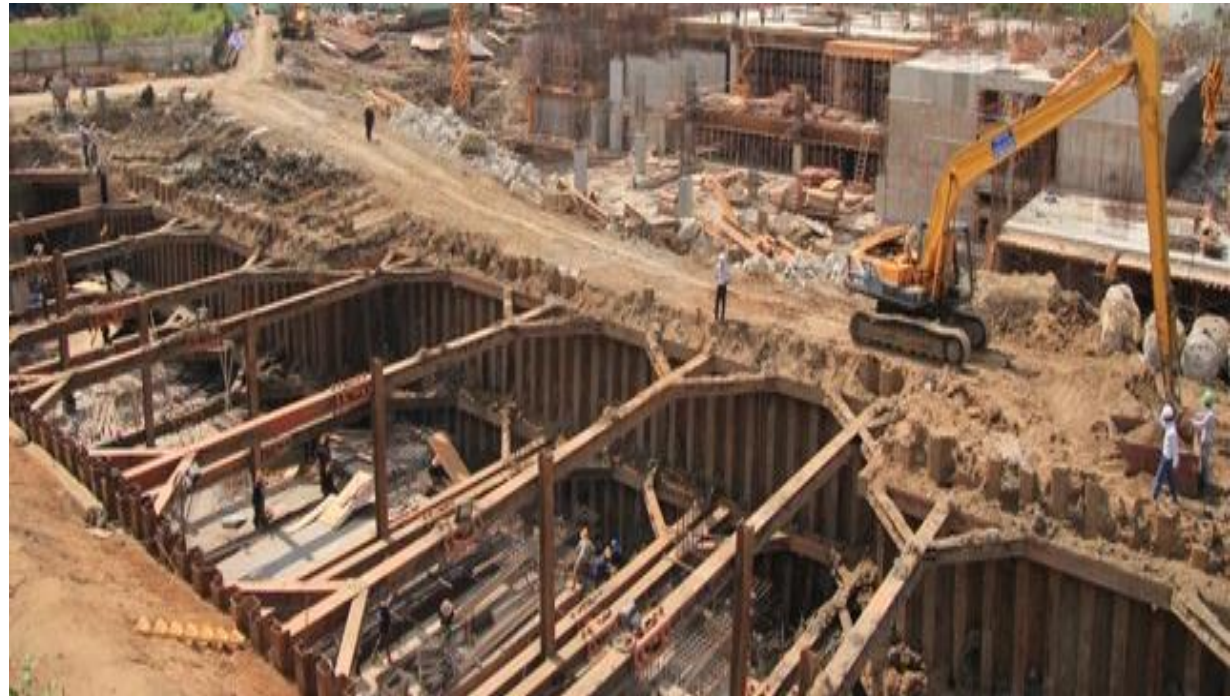
## Case 5: District 8 – June 2015

- 2 basement levels with - 9m deep excavation
- bottom-up construction
- Steel sheet-piles with lateral support from steel strutting system
- Excessive adjacent ground settlement (200-400mm)
- Failure of sheet piled wall due to failure of strutting system

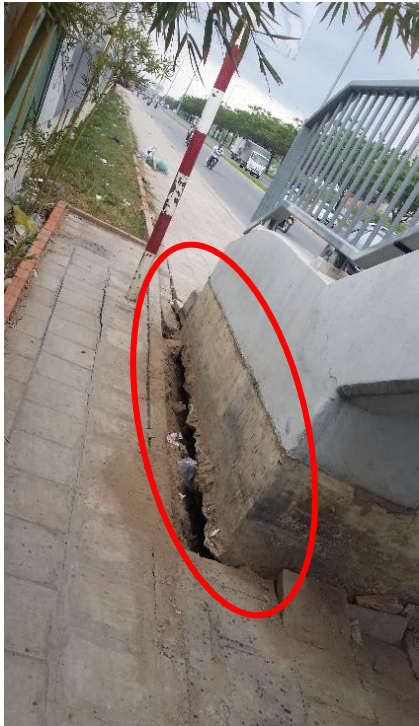
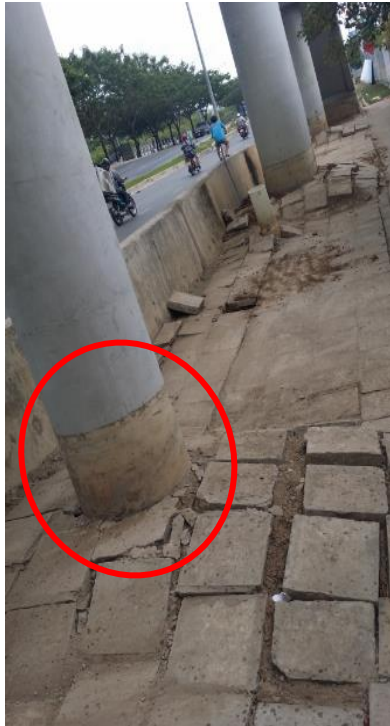
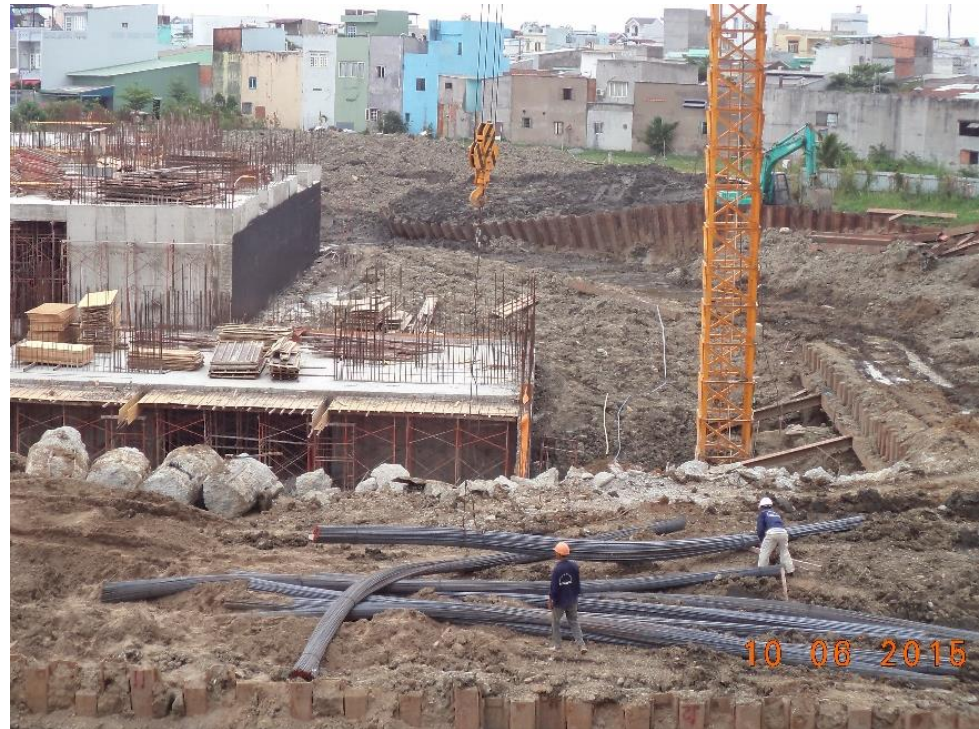
## Case 5 (continued...)

Observed settlement of the adjacent walkway is about 20 to 40 cm

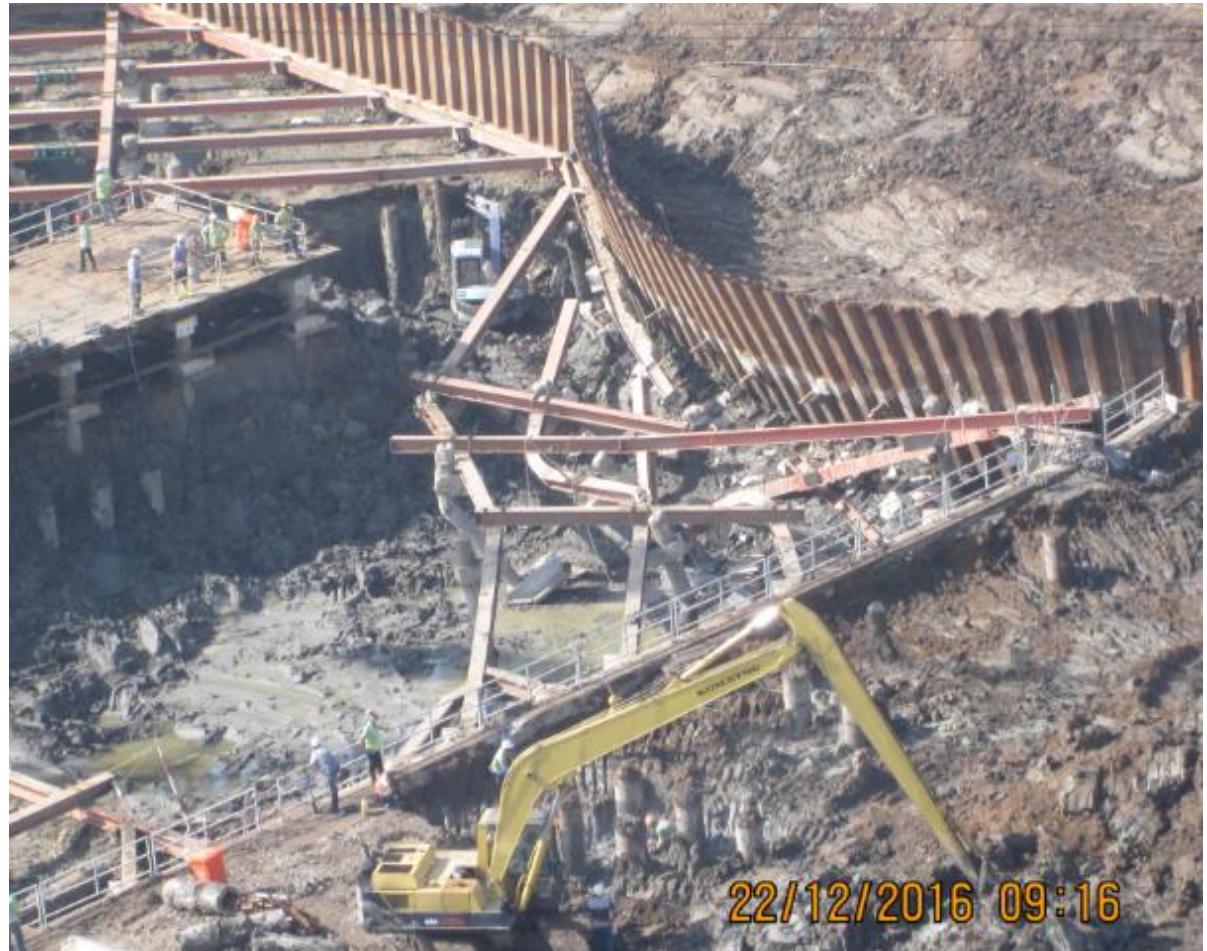
## Case 6: District 7 – December 2016

- 2 basement levels with - 9m-11.5m deep excavation
- Bottom-up construction
- Steel sheet-piles with lateral support from steel strutting system
- Failure of steel strutting system leading to collapse of the sheet piling

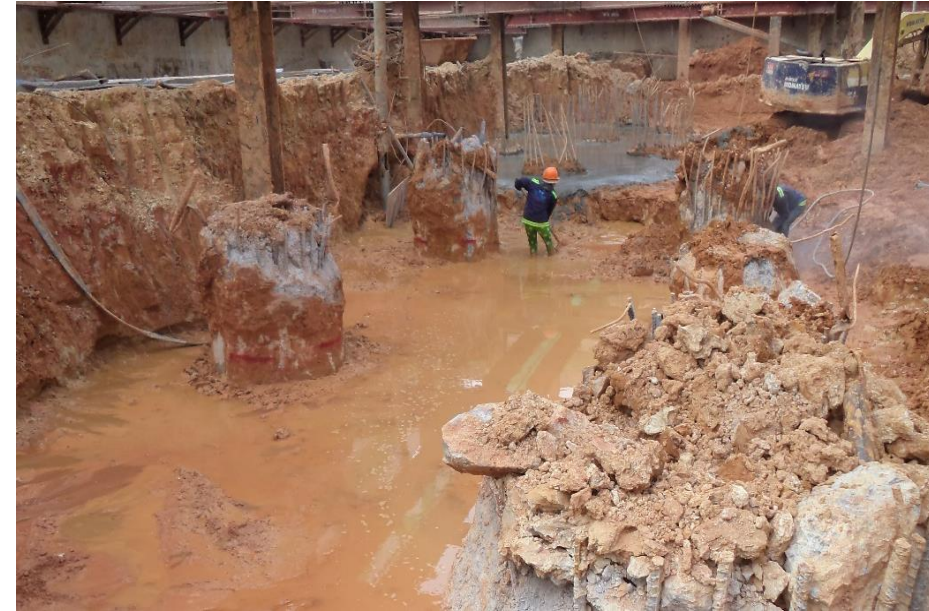
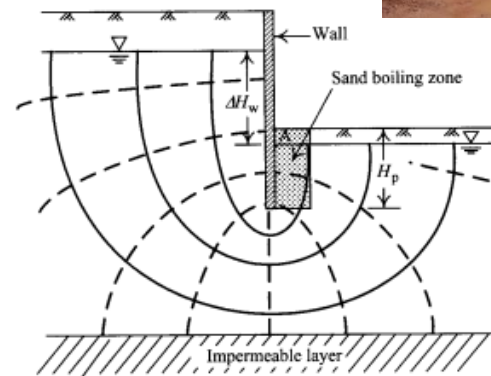
## Case 7: District 7

- 2 basement levels with -9m-11.5m deep excavation
- Very thick sand layer situates below the ground level
- Bottom-up construction
- D-wall with lateral support from steel strutting system
- The sand boiling due to short D-wall.
- Inadequate water level management.
